House (Tract #903)

HABS No. MO-1240

HISTORIC AMERICAN BUILDINGS SURVEY

Location: 0.3 miles east of Route 0, 0.7 miles southeast of its intersection with Route 83, 1.3 miles south-south-east of Fairfield, Warsaw Vicinity, Benton County, Missouri.

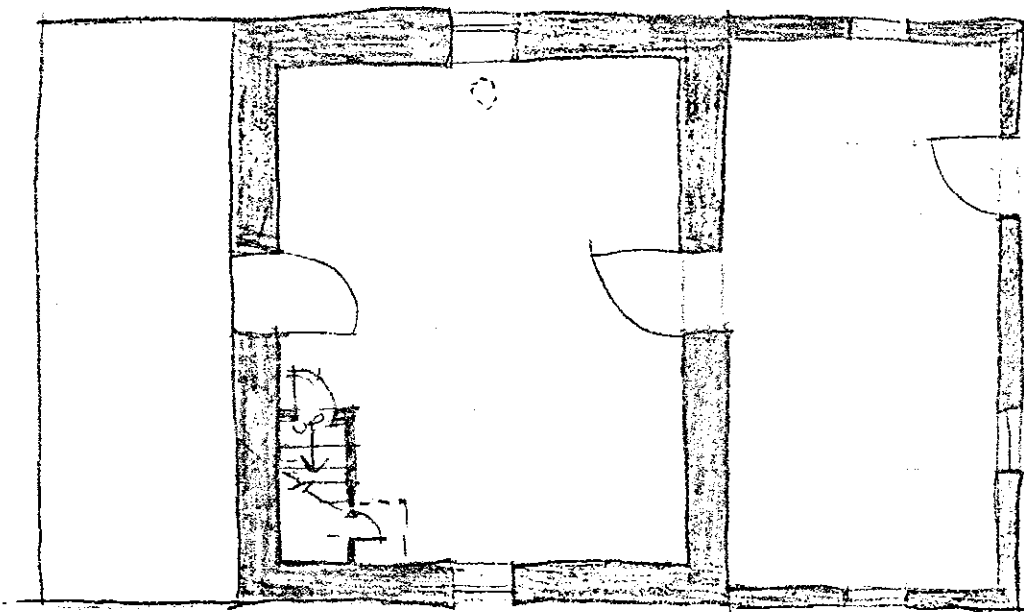
FIRST FLOOR PLAN # 903

1. Floor plans: The first floor has two rooms: The roughly square room of the original log portion and the rectangular room added across the rear, probably used as a kitchen. The second floor is only one room, in the original log portion.

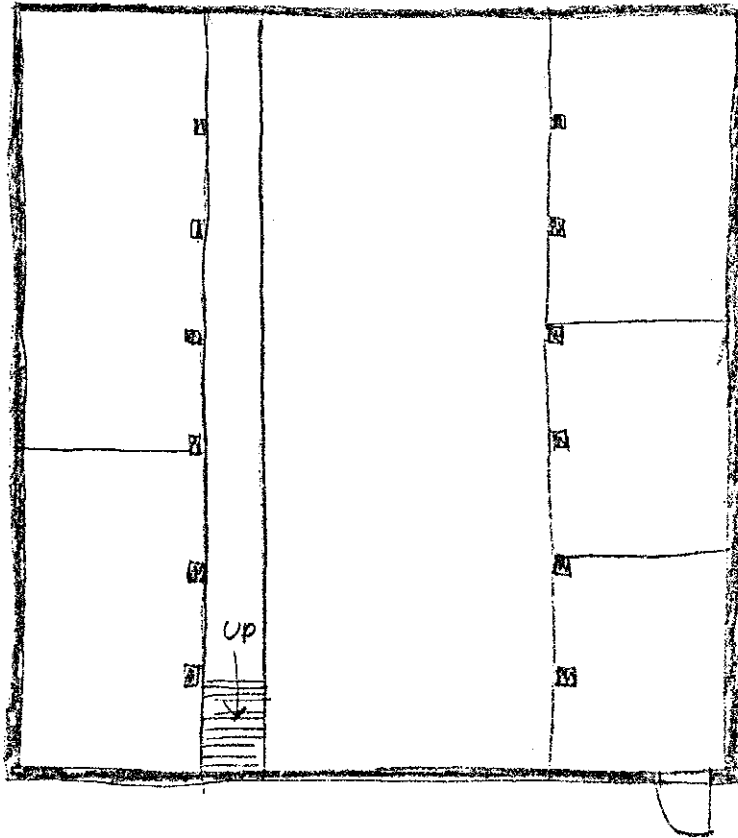
→ N BARN PLAN #903

1. General setting: The house faces west and sits east of a dirt road. A small family cemetery is hidden by trees west of the road.
2. Outbuildings: Northeast of the house is a three-aisle barn with a cattle-chute to one side of the wide central aisle. Notches in the vertical members supporting the roof look as if these members were originally used in another structure, perhaps as a perimeter beam to receive joists or other horizontal members. Vertical siding may have been board and batten originally, but battens are now gone. The building is 37'-6" wide by 40' deep, and has wood shingles on its gable roof.
